**NEW MEXICO  
ENVIRONMENT DEPARTMENT**

Re: **Mirador Subdivision; Construction Stormwater; SIC 1522; NPDES Compliance Evaluation Inspection; NPDES #NMR1001AH; September 13, 2018**

## NPDES Compliance Inspection Report

**Mirador Subdivision  
Guzman Construction Solutions  
NMR1001AH**

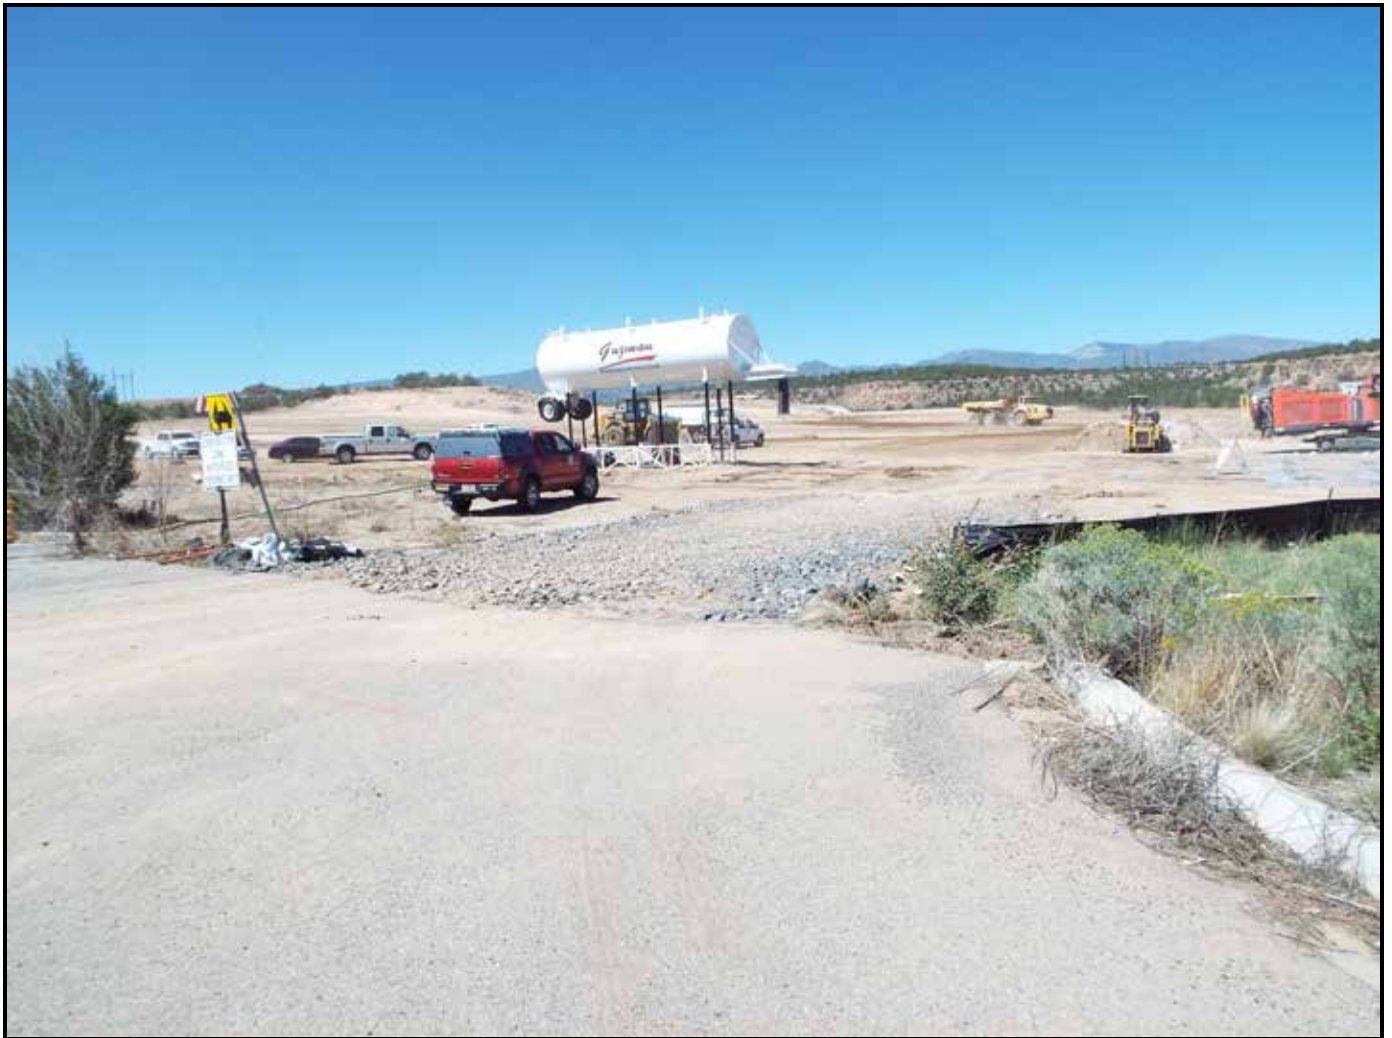
Photo # 1

Photographer: Daniel Valenta	Date: 9/13/2018	Time: 1254 hours
City/County: White Rock/Los Alamos		
Location: Sherwood Blvd and NM Hwy 4		
Subject: Entrance to Mirador Subdivision a 50-acre subdivision.

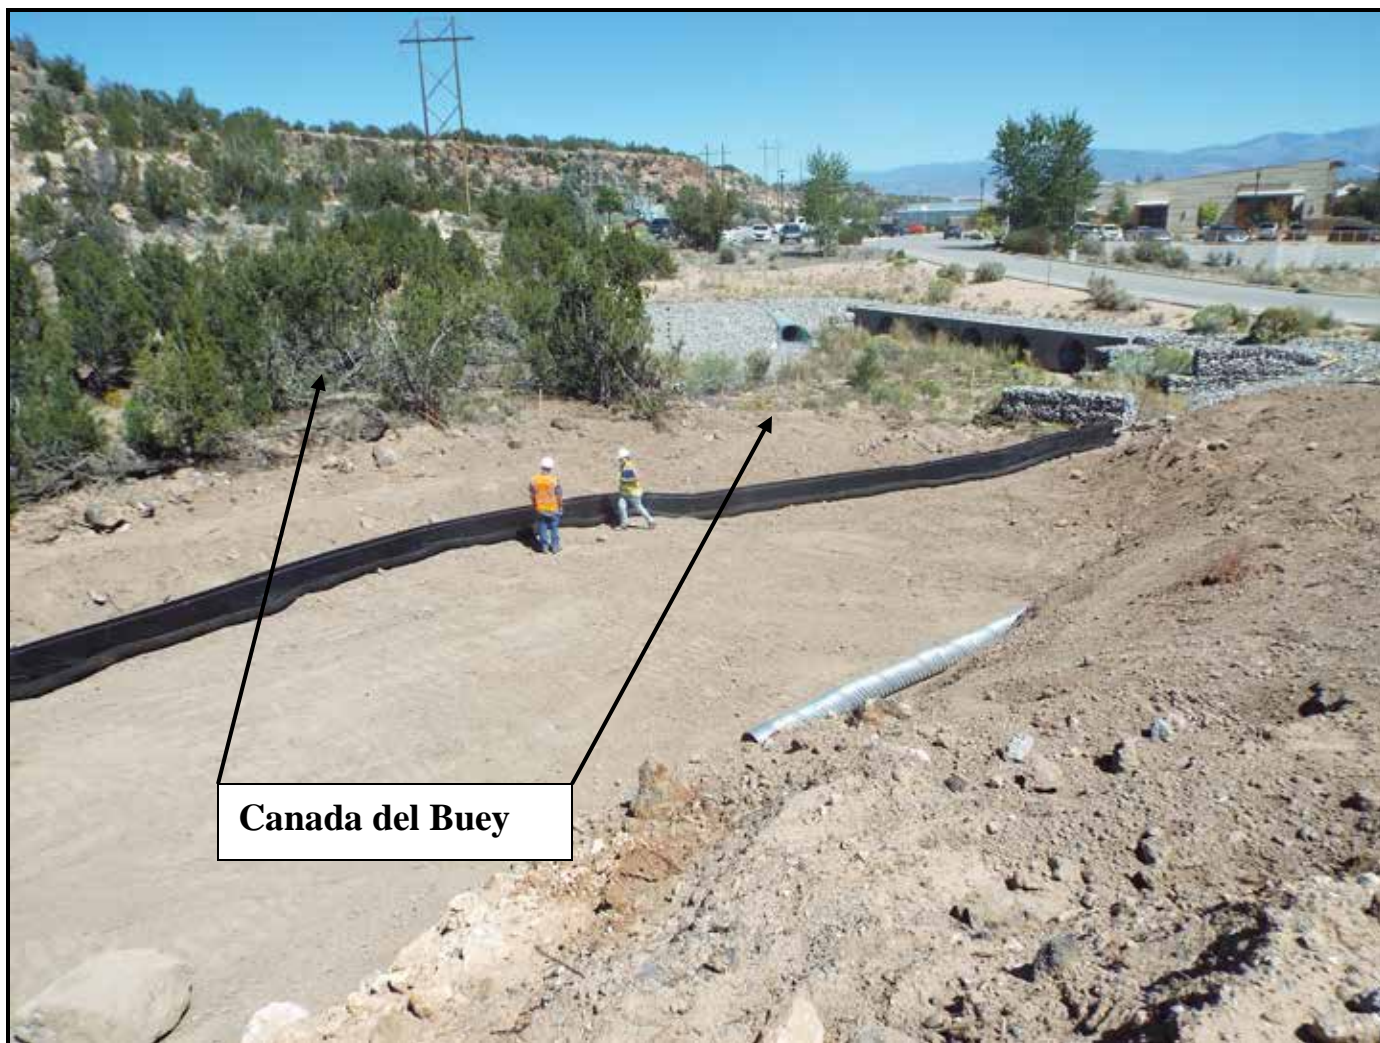
Photo # 2

Photographer: Daniel Valenta	Date: 9/13/2018	Time: 1342 hours
City/County: White Rock/Los Alamos		
Location: Sherwood Blvd and NM Hwy 4		
Subject: East side of subdivision which borders the Canada del Buey a waters of the US.

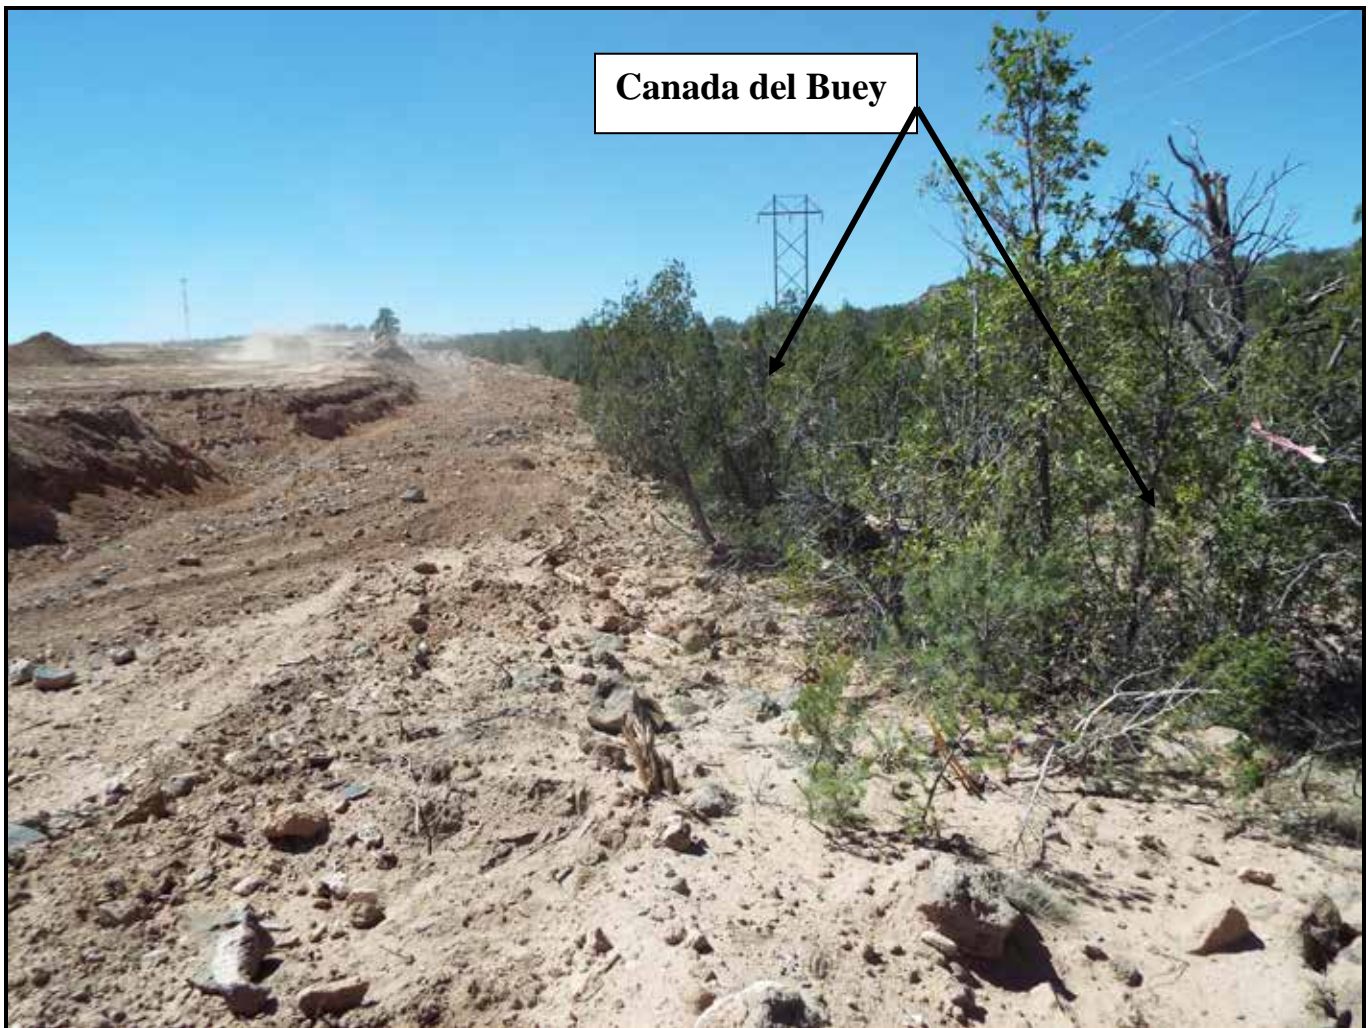
Photo # 3

- BMP's along the Canada del Buey appear to be misplaced or missing completely. No buffer zone was in place or enhanced BMP's to act as 50-foot buffer. Buffer Compliance and Compliance Alternatives see CGP 2.2.1 and Appendix G – Buffer

Photographer: Daniel Valenta	Date: 9/13/2018	Time: 1351 hours
City/County: White Rock/Los Alamos		
Location: Sherwood Blvd and NM Hwy 4		
Subject: Construction activities have moved dirt up to the edge of the Canada del Buey.

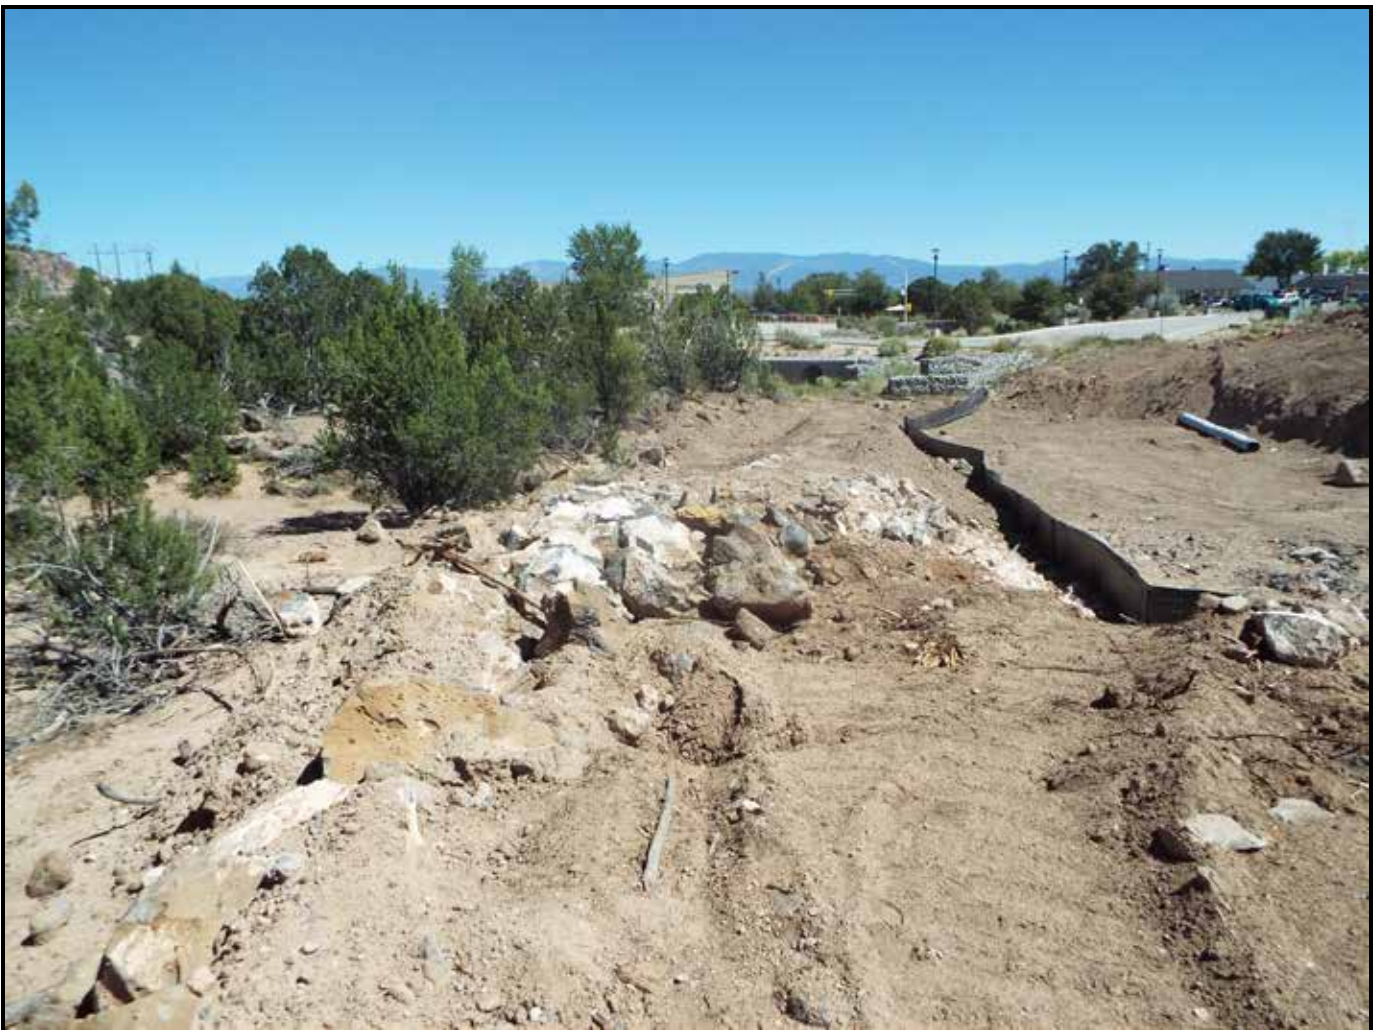
Photo # 4

- The buffer permit requirements are noted in the project SWPPP page 24. "Surface waters can be found within 50 feet of earth disturbing activities. The Operator will provide and maintain an undisturbed natural buffer that is less than 50 feet. It is supplemented by additional erosion and sediment controls, which in combination achieves the sediment load reduction equivalent to a 50-foot undisturbed natural buffer." The project SWPPP notes the site may discharge to a WOUS. However no buffer was retained or sediment load reduction equivalent put in place.
- Site inspection noted a lack of suffice BMP's, misplaced BMP's or complete absence of stormwater controls. See attached pictures and rain events on attachment 2.

Photographer: Daniel Valenta	Date: 9/13/2018	Time: 1350 hours
City/County: White Rock/Los Alamos		
Location: Sherwood Blvd and NM Hwy 4		
Subject: The Canada del Buey has no buffer zone or enhanced BMP's. The project did not apply for or receive a ACOE 404 permit.

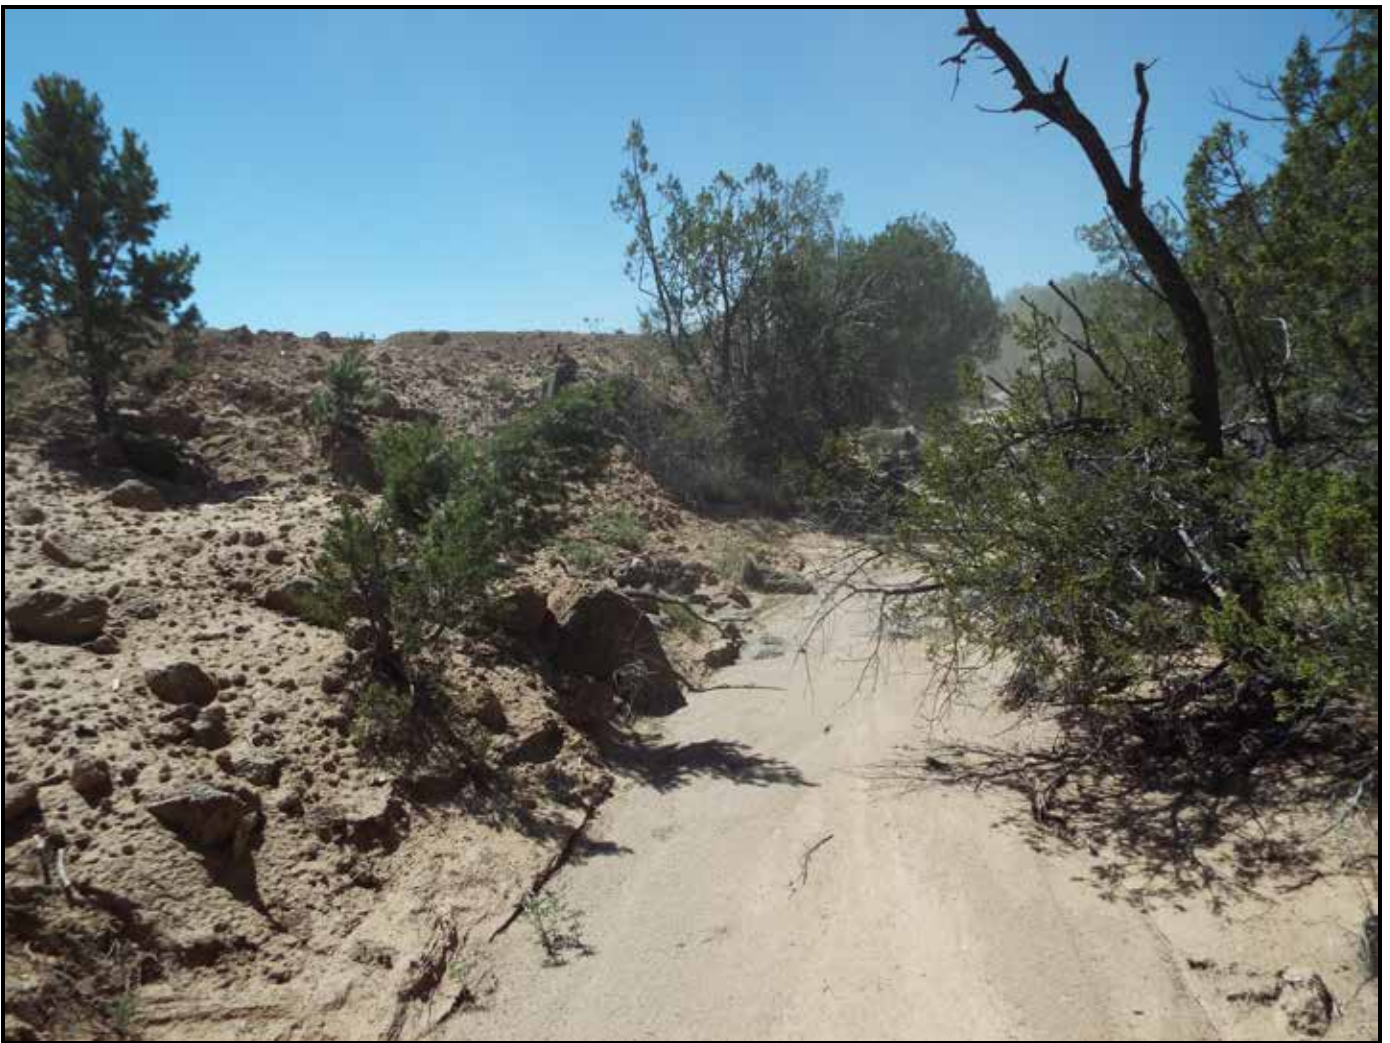
Photo # 5

Photographer: Daniel Valenta	Date: 9/13/2018	Time: 1352 hours
City/County: White Rock/Los Alamos		
Location: Sherwood Blvd and NM Hwy 4		
Subject: The Canada del Buey has no buffer zone or enhanced BMP's. The project did not apply for or receive a ACOE 404 permit.

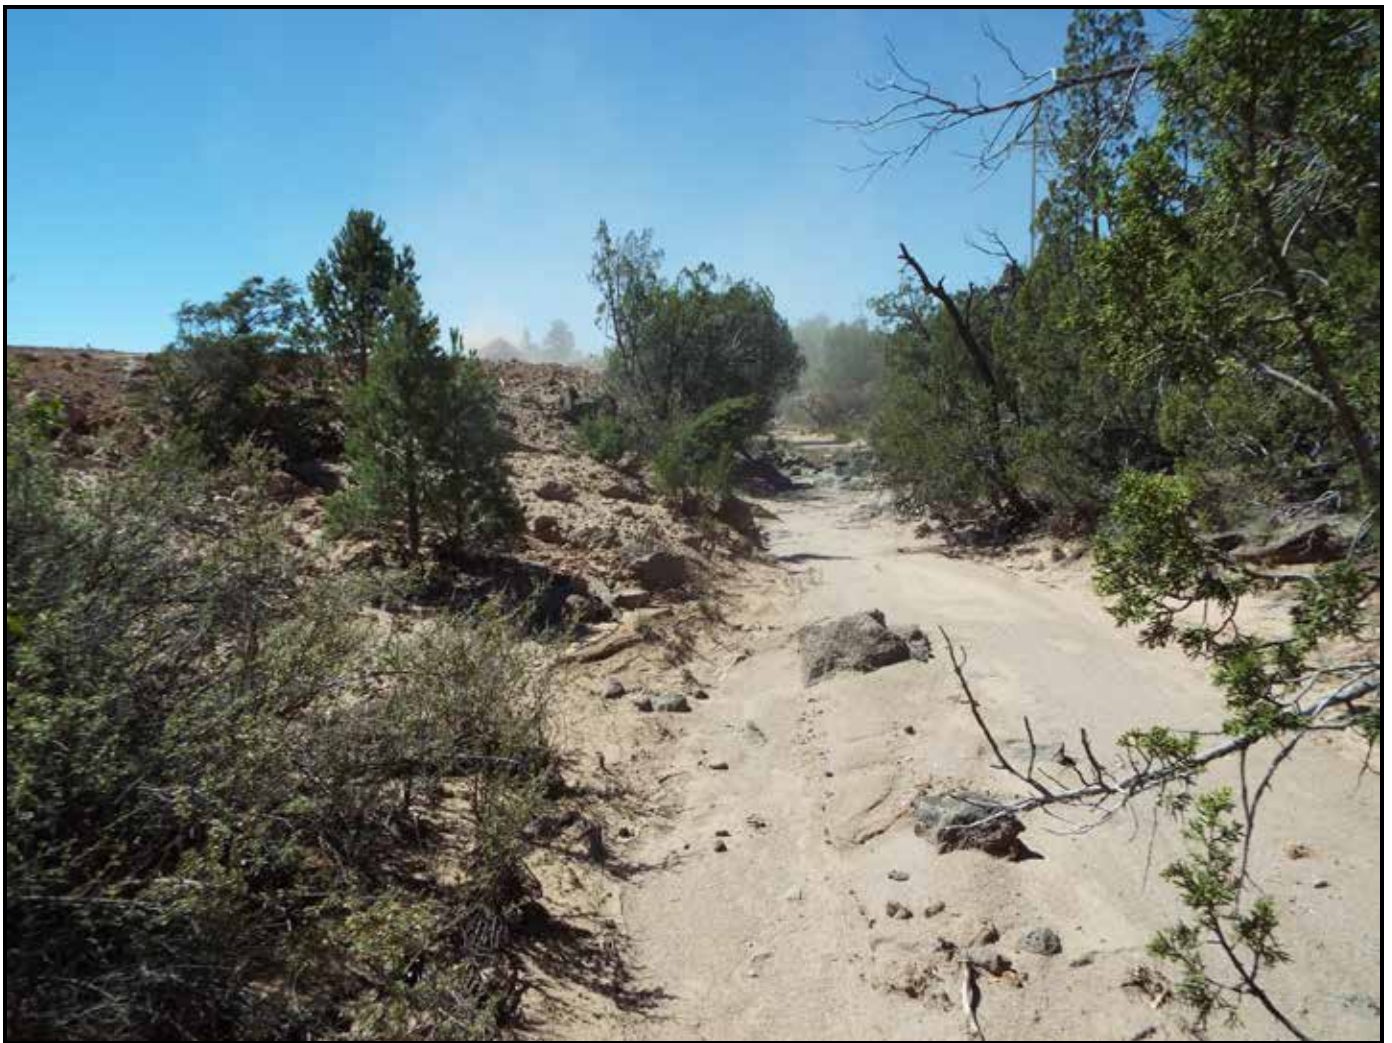
Photo # 6

Photographer: Daniel Valenta	Date: 9/13/2018	Time: 1352 hours
City/County: White Rock/Los Alamos		
Location: Sherwood Blvd and NM Hwy 4		
Subject: The Canada del Buey has no buffer zone or enhanced BMP's. The project did not apply for or receive a ACOE 404 permit.
